Padcal Mine, Philippines

Padcal Spillway General View, Philippines

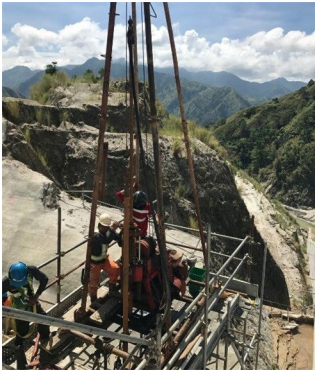
Borehole drilling for extensometer installation

This being an already-existing dam under expansion, retrofitting the existing structure with new instruments met significant hurdles. Installation of the multipoint extensometers required drilling in difficult conditions: drilling was performed from the top of the dam, through the gallery and into the soil, going past workers in the gallery. Furthermore, the combination of a sandy supporting soil and the high pressure created by the dam and water head made installation of these instruments unusually complex as the boreholes would collapse instantly. However, the fact that the dam was still under expansion allowed for creative and novel instrumentation installations.

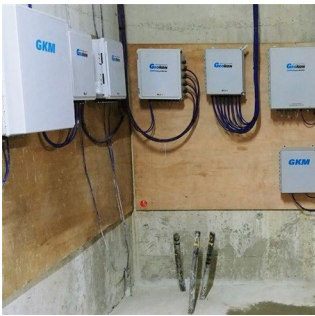
Automatic data acquisition system

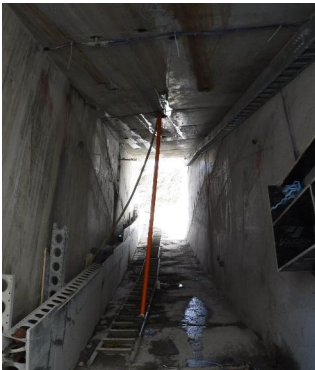
Inclinometer casing being slid through the gallery

This ambitious project required a significant amount of instrumentation for close monitoring during construction, operation and for future maintenance. Instruments included in-place inclinometers to follow any deformation in the structure, joint meters across concrete blocks, piezometers within the dam and extensometers underneath. In-place inclinometers were installed in the already-built concrete structure between the spillway and a gallery. Multipoint extensometers were installed through the existing structure into the soil underneath the dam. Finally, piezometers were casted directly into the blocks as the concrete was poured.
