Welland Canal Lock | Canada's St. Lawrence Seaway, Ontario

Welland Canal lock in Ontario , connecting Lake Ontario and Lake Erie, part of Canada's St. Lawrence Seaway

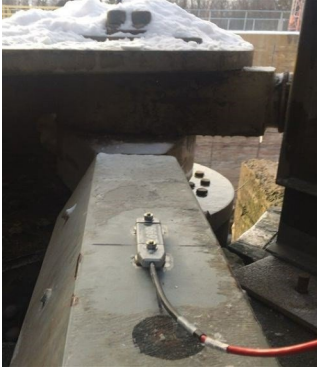
Strain gauges on the gates mechanisms to track dynamic strain during operations

-Gate Monitoring | GKM was mandated to install strain gauges on the gates mechanisms to track dynamic strain and stress during operations.

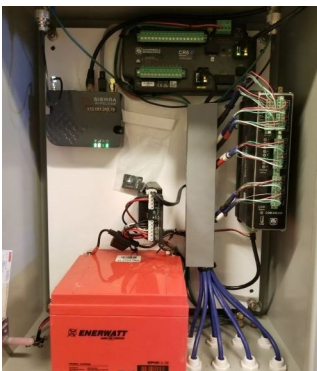
Custom high-speed data loggers
